# Frog Environmental BMP Case Study

## Concrete Company in Southern California

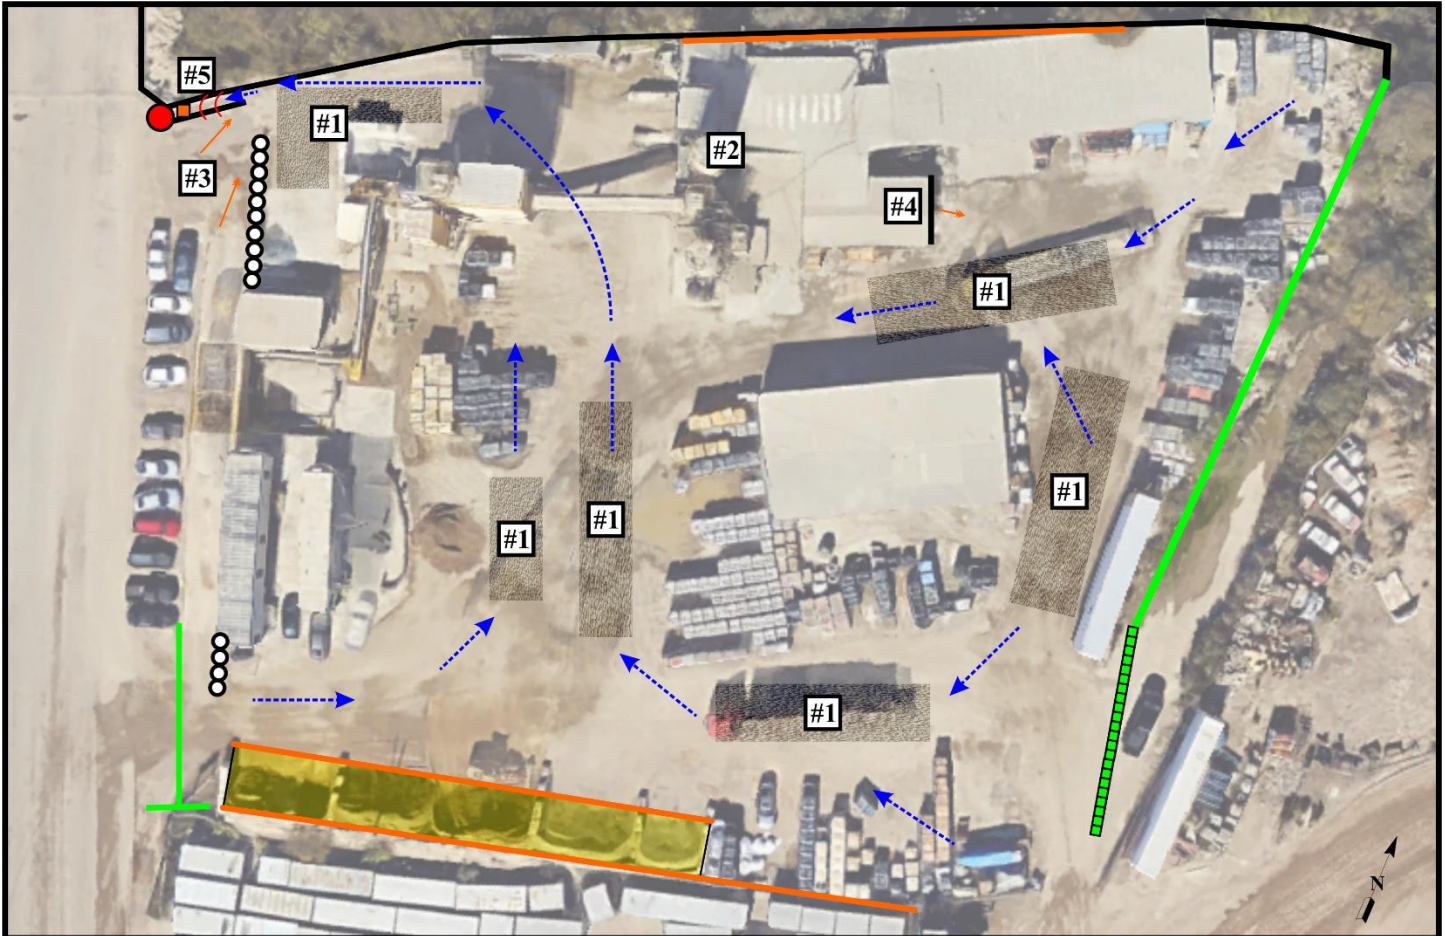
## Site Diagram Indicating Implemented BMPs

- High Total Suspended Solids (TSS) and high Iron (Fe) were problems for this facility due to concrete dust.
- Industrial material stockpiles were causing high TSS.
- Runoff needed to be minimized to decrease pollutants.
- Water flow needed to be slowed to promote water retention to aid settling of solids.
- Industrial materials needed to be covered to avoid exposure.
- Discharge needed to be removed at one of the outfalls.
- Perimeter was eroding and discharging into a creek.
- Run-on from neighboring businesses was causing problems.

- Gravel-Lined Basin	- Tarped Prior to Rain	- Industrial Wattle	- Eco-Block	<b>#1:</b> Disperse flocculent in basins
- Re-grading	- Straw Wattle(s)	- Hay Bale	- Sample Point (#7)	<b>#2:</b> Implement regular vacuuming schedule
- Earthen Berm	- Concrete Berm	- Sandbag	- Storm Water Flow	<b>#3:</b> Re-grade driveway
				<b>#4:</b> Re-direct water from production area
				<b>#5:</b> Deploy wattles and hay bale
